Docket No. 217 – Development and Management Plan Inspection

Northeast Utilities Service Company Certificate of Environmental Compatibility and Public Need for the construction of a 345-kV electric transmission line and reconstruction of an existing 115-kV electric transmission line between Connecticut Light and Power Company's Plumtree Substation in Bethel, through the towns of Redding, Weston, and Wilton, and to the Norwalk Substation in Norwalk, Connecticut.

Date: May 10, 2006

Location: Transition Stations: Hoyts Hill, Archers Lane, Norwalk Junction

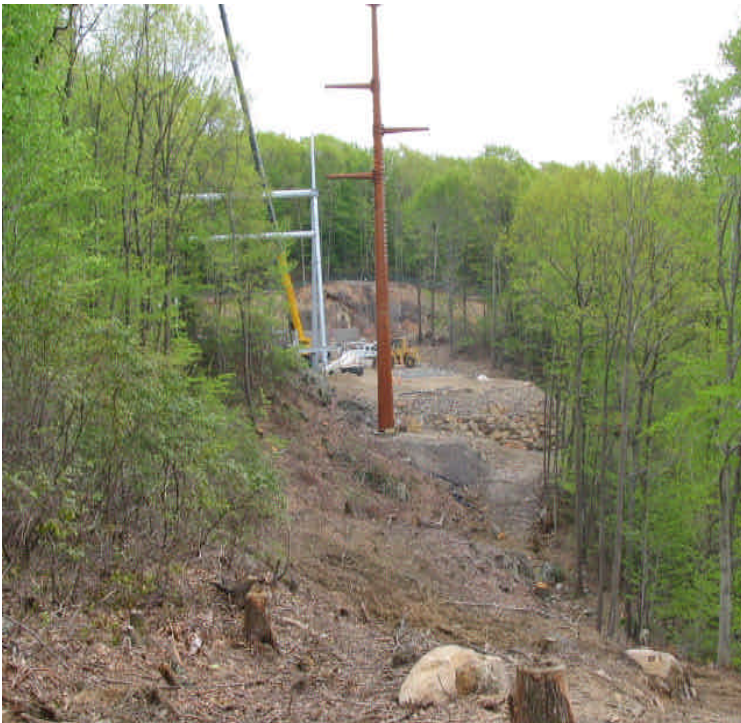
Archers Lane: Photo on the left shows a view of the station pad with structures being installed. Photo on the right shows the stone wall along the access drive. Minor amounts of water and sediment were filtering through here but it was not impacting the wetland. 5/10/06.

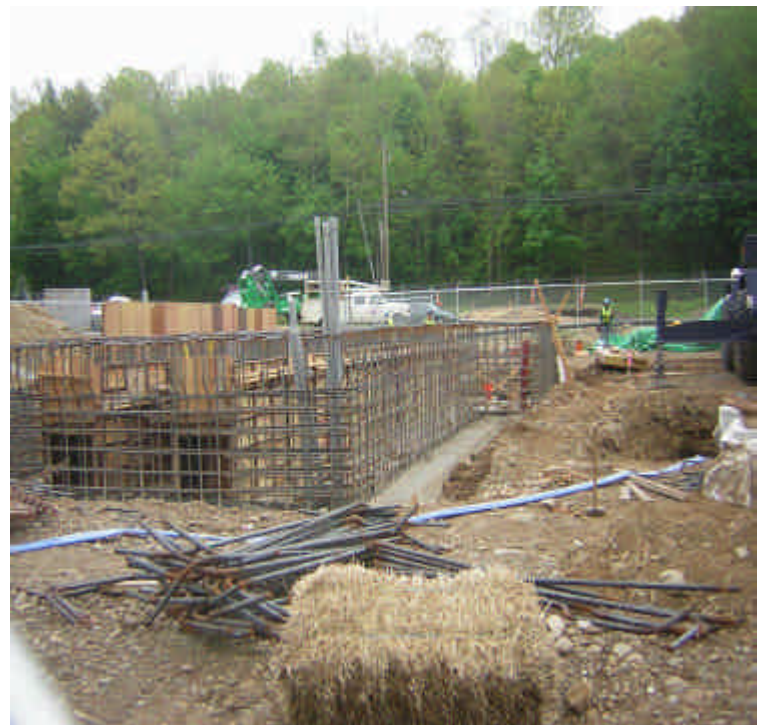
Norwalk Junction: Photo on the left shows the recently restored slope of the swale. EC matting remains in good shape. Photo on the right shows minor dewatering with haybales in place to filter out sediment prior to going to the wetland. 5/10/06.
